PENNSY
Today

PENNSY
Today
WINTER 2006

CONTINUOUS IMPROVEMENT: Air Hose Support

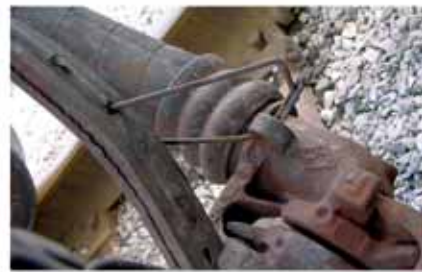
Air hose separations have a huge negative impact on rail operations. Failed air hose supports are one of the leading causes for these separations. Such events typically result from failures in the strap material or the support clips. Rubber straps simply don't hold up to UV or environmental degradation and eventually stretch under loading to the point of failure. Metal clips are prone to rotation within the glad hand in transit and failure from resulting lateral loading. Wire rope straps bring with them their own problems including wear and fraying that lead to eventual failure.

View of a deformed glad hand clip

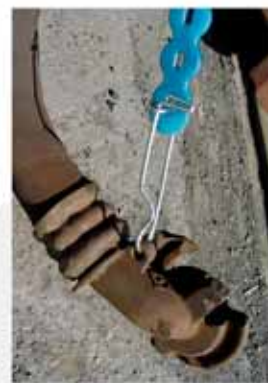
Straps designed with advanced polymers overcome the UV and environmental degradation shortcomings of rubber and wire cable. The polymer material demonstrates superior loading capabilities and resists permanent elongation therefore reducing the frequency of support adjustments. A new clip design resists rotation within the glad hand to eliminate lateral loading failure.

Polymer support with revised lower clip

- Polymer strap has a longer service life
- Requires less frequent adjustments
- Eliminates clip failure from lateral loading
- Proven in widespread usage
- Lower failure rate
- Exceeds AAR S-4006 requirements

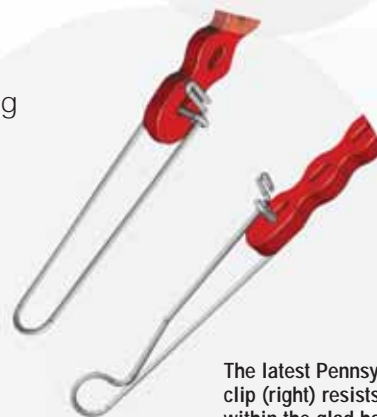
The latest Pennsy support clip (right) resists rotation within the glad hand as experienced with traditional support clips (left)
